Figure A-2
Site-Wide Soil Sampling Results for
Soil Alternatives: Copper
Riverside Industrial Park Superfund Site
Essex County, New Jersey

Riverside Industrial Park Superfund Site

Essex County, New Jersey

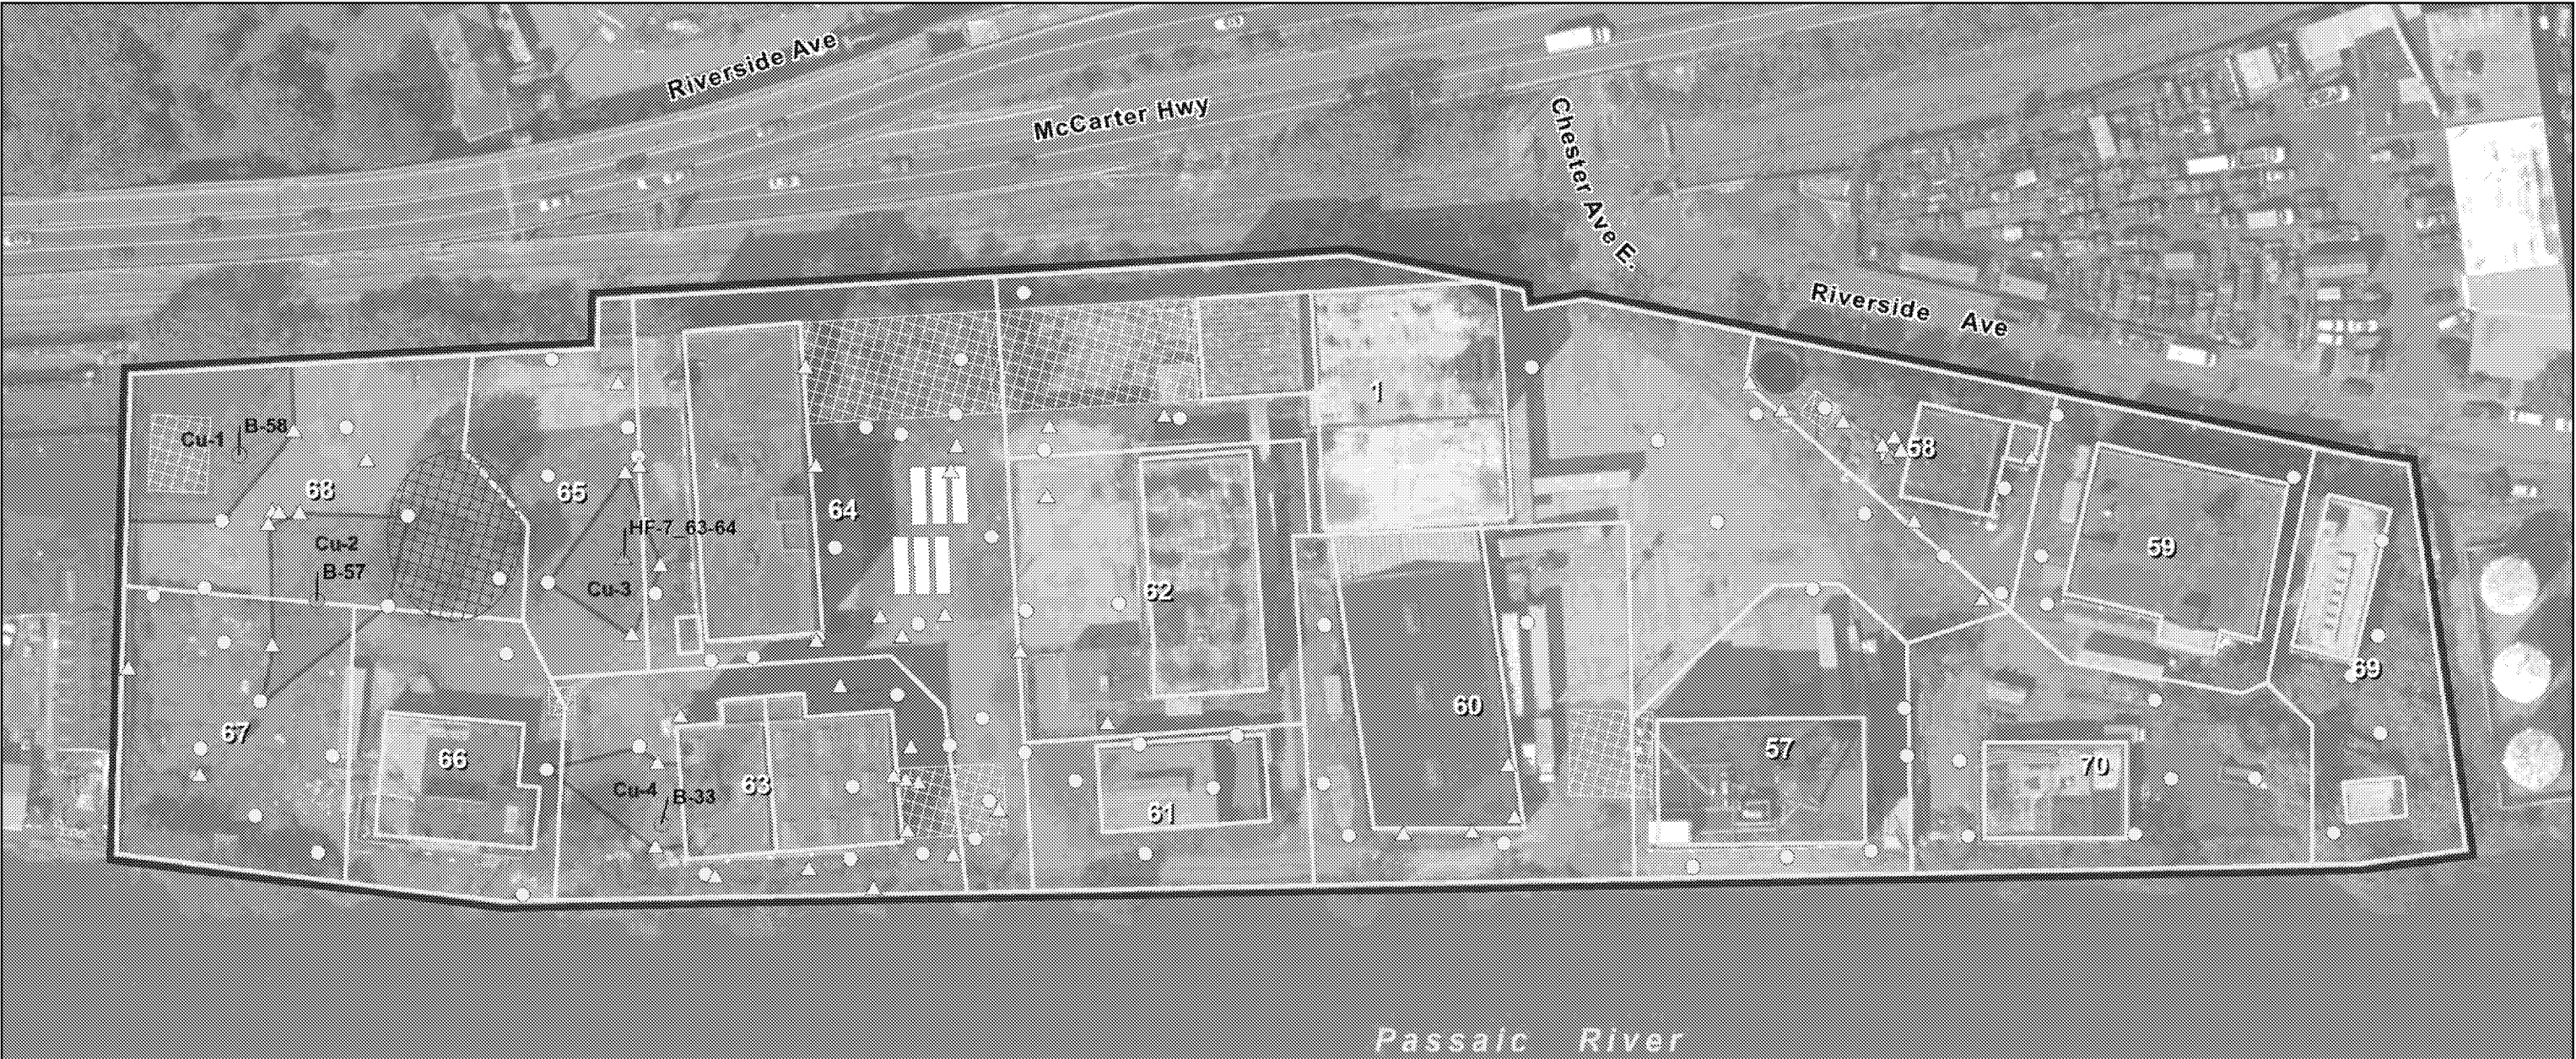
Area	SqFt	Acres
Cu-1	5,743.13	0.13
Cu-2	4,433.10	0.10
Cu-3	2,438.08	0.06
Cu-4	2,091.23	0.05

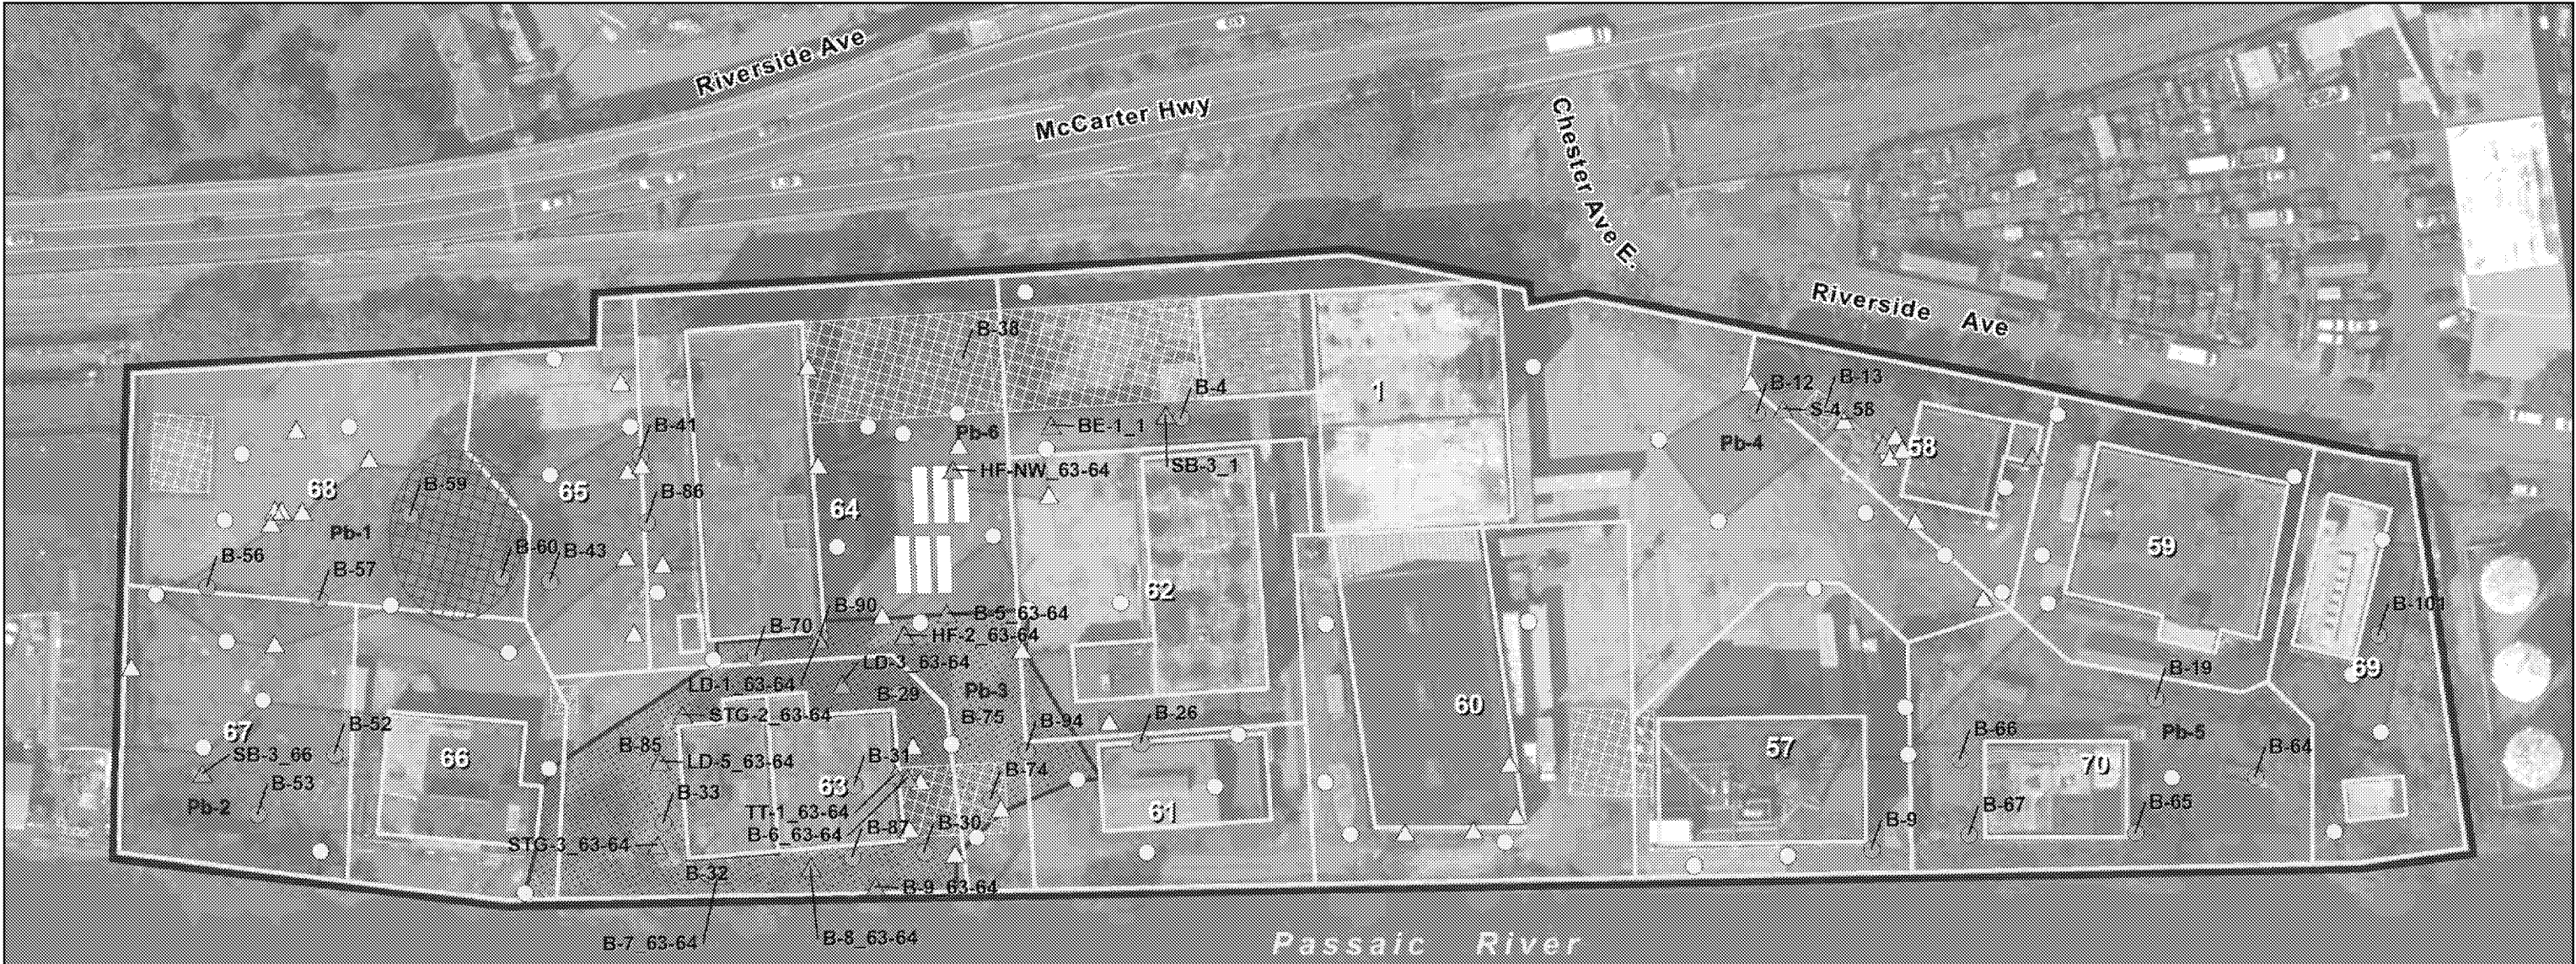
Figure A-3

Area	SqFt	Acres
Pb-1	18,516.69	0.43
Pb-2	9,187.38	0.21
Pb-3	26,921.45	0.62
Pb-4	4,740.73	0.11
Pb-5	26,631.58	0.61
Pb-6	9,187.91	0.21

Footprint of Soil Alternative 4 for Lead Removal
- RI Soil Boring

Site-Wide Soil Sampling Results for Soil Alternatives: Lead

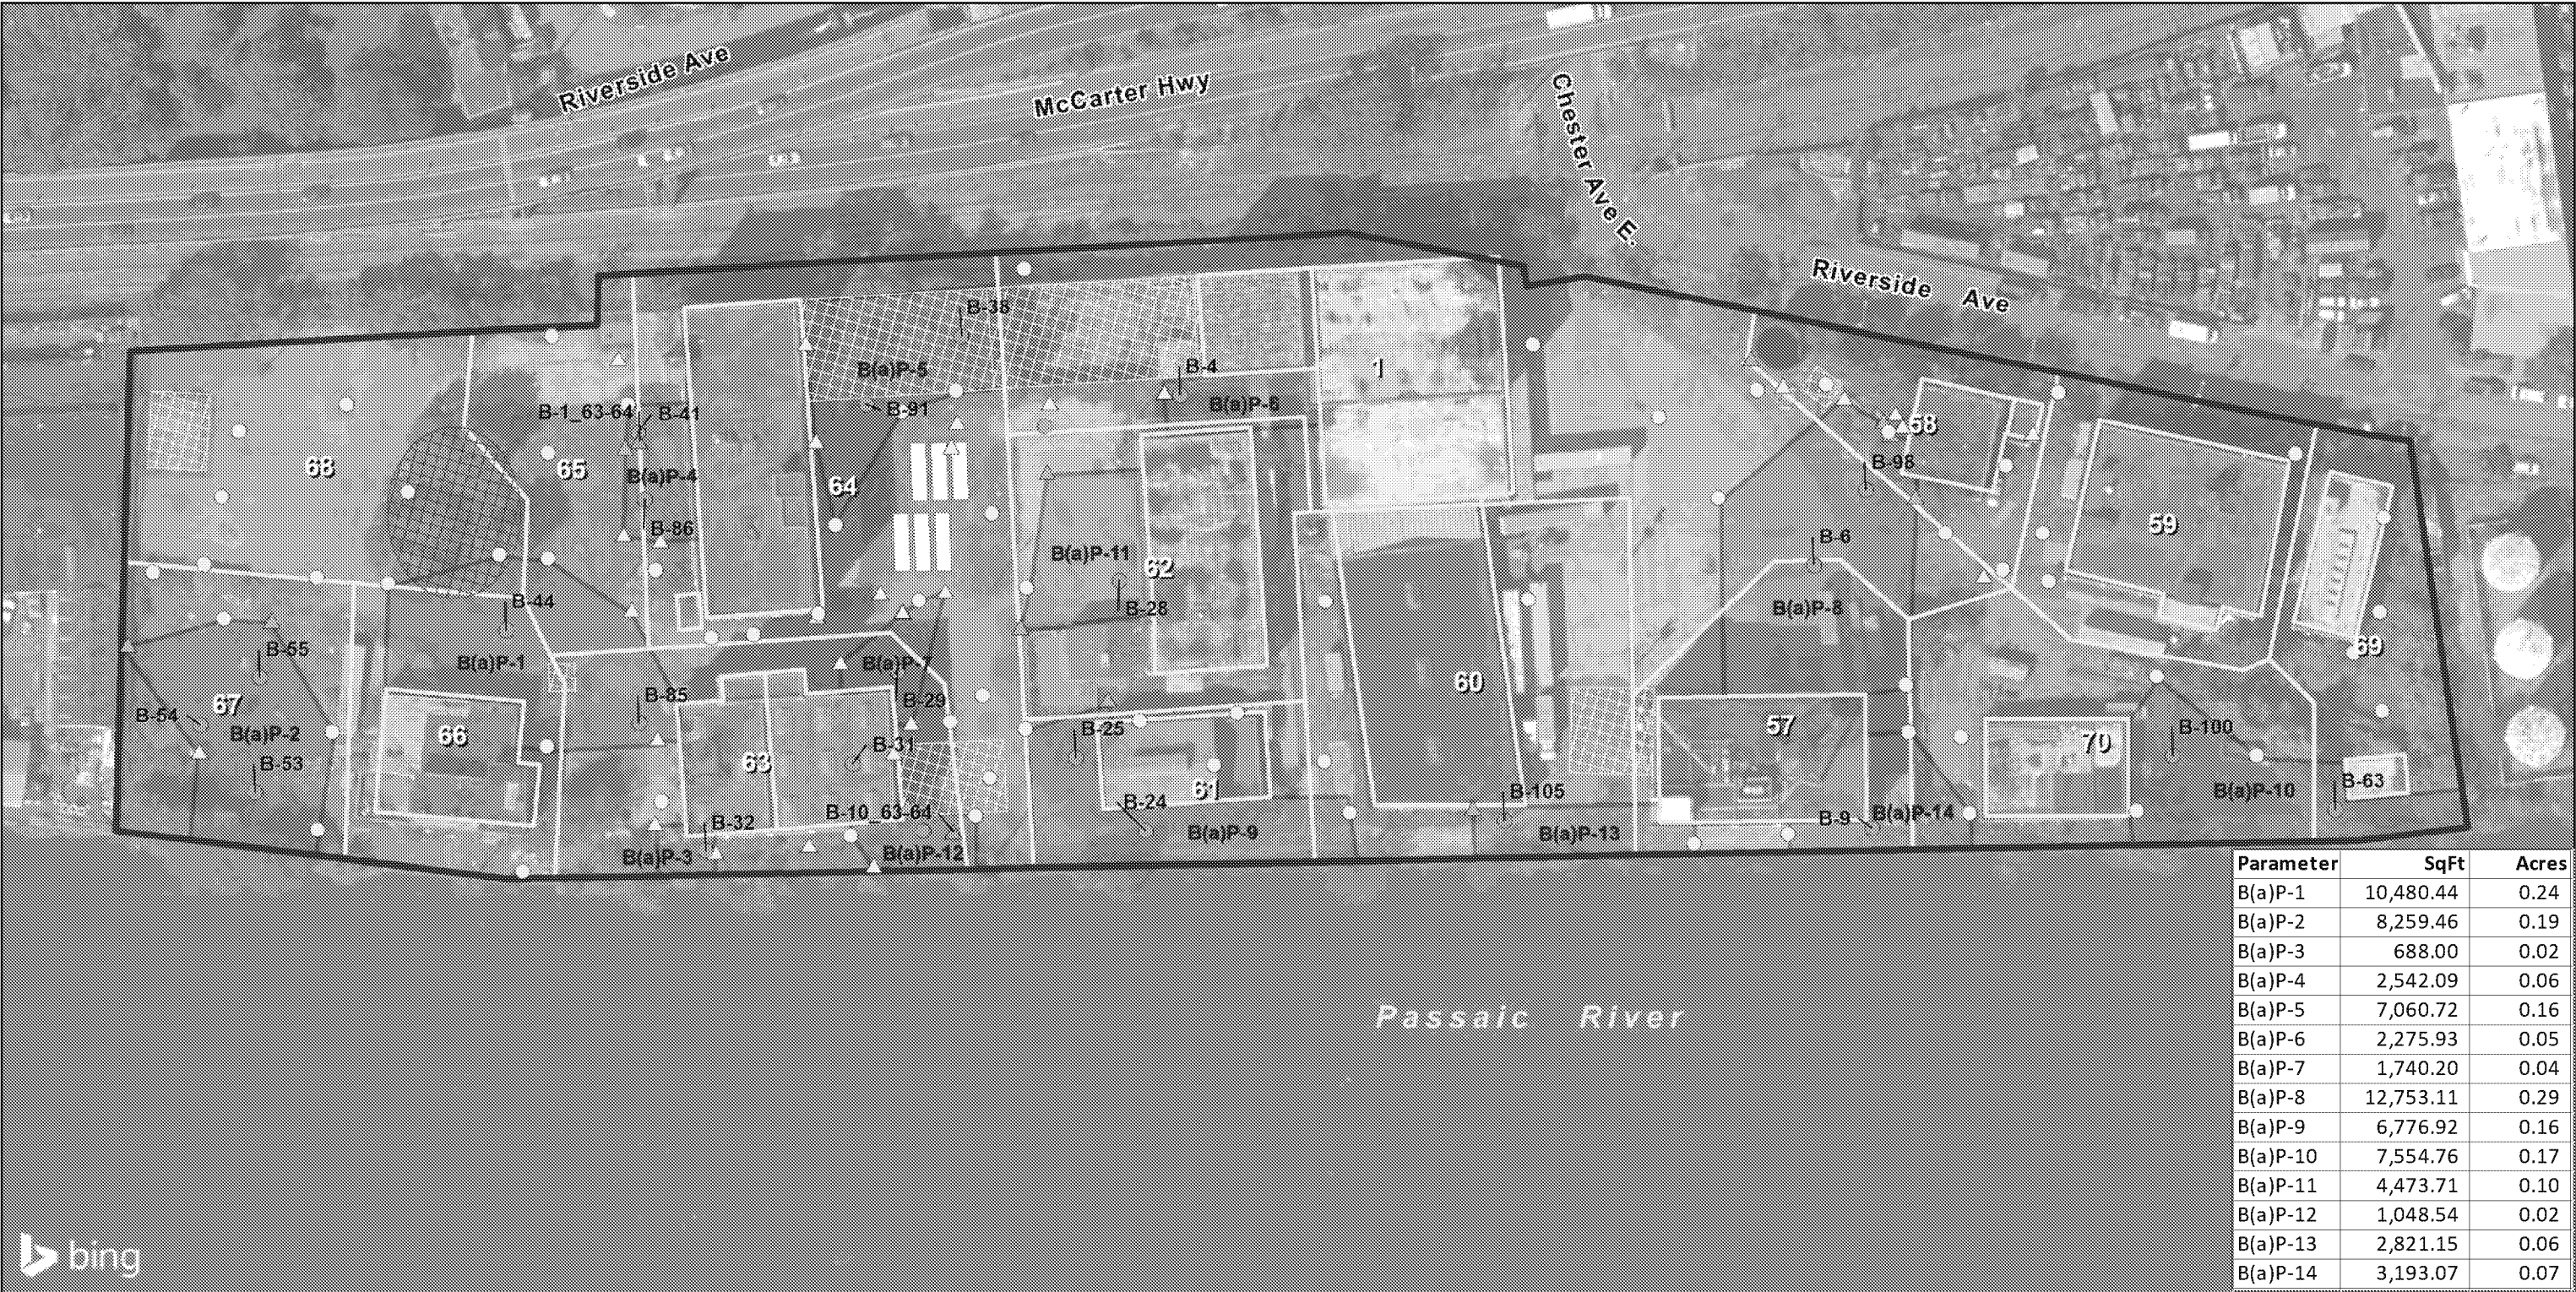
Figure A-5

Parameter	SqFt	Acres
B(a)P-1	10,480.44	0.24
B(a)P-2	8,259.46	0.19
B(a)P-3	688.00	0.02
B(a)P-4	2,542.09	0.06
B(a)P-5	7,060.72	0.16
B(a)P-6	2,275.93	0.05
B(a)P-7	1,740.20	0.04
B(a)P-8	12,753.11	0.29
B(a)P-9	6,776.92	0.16
B(a)P-10	7,554.76	0.17
B(a)P-11	4,473.71	0.10
B(a)P-12	1,048.54	0.02
B(a)P-13	2,821.15	0.06
B(a)P-14	3,193.07	0.07

Site-Wide Soil Sampling Results for
Soil Alternatives: Benzo(a)pyrene
Riverside Industrial Park Superfund Site
Essex County, New Jersey

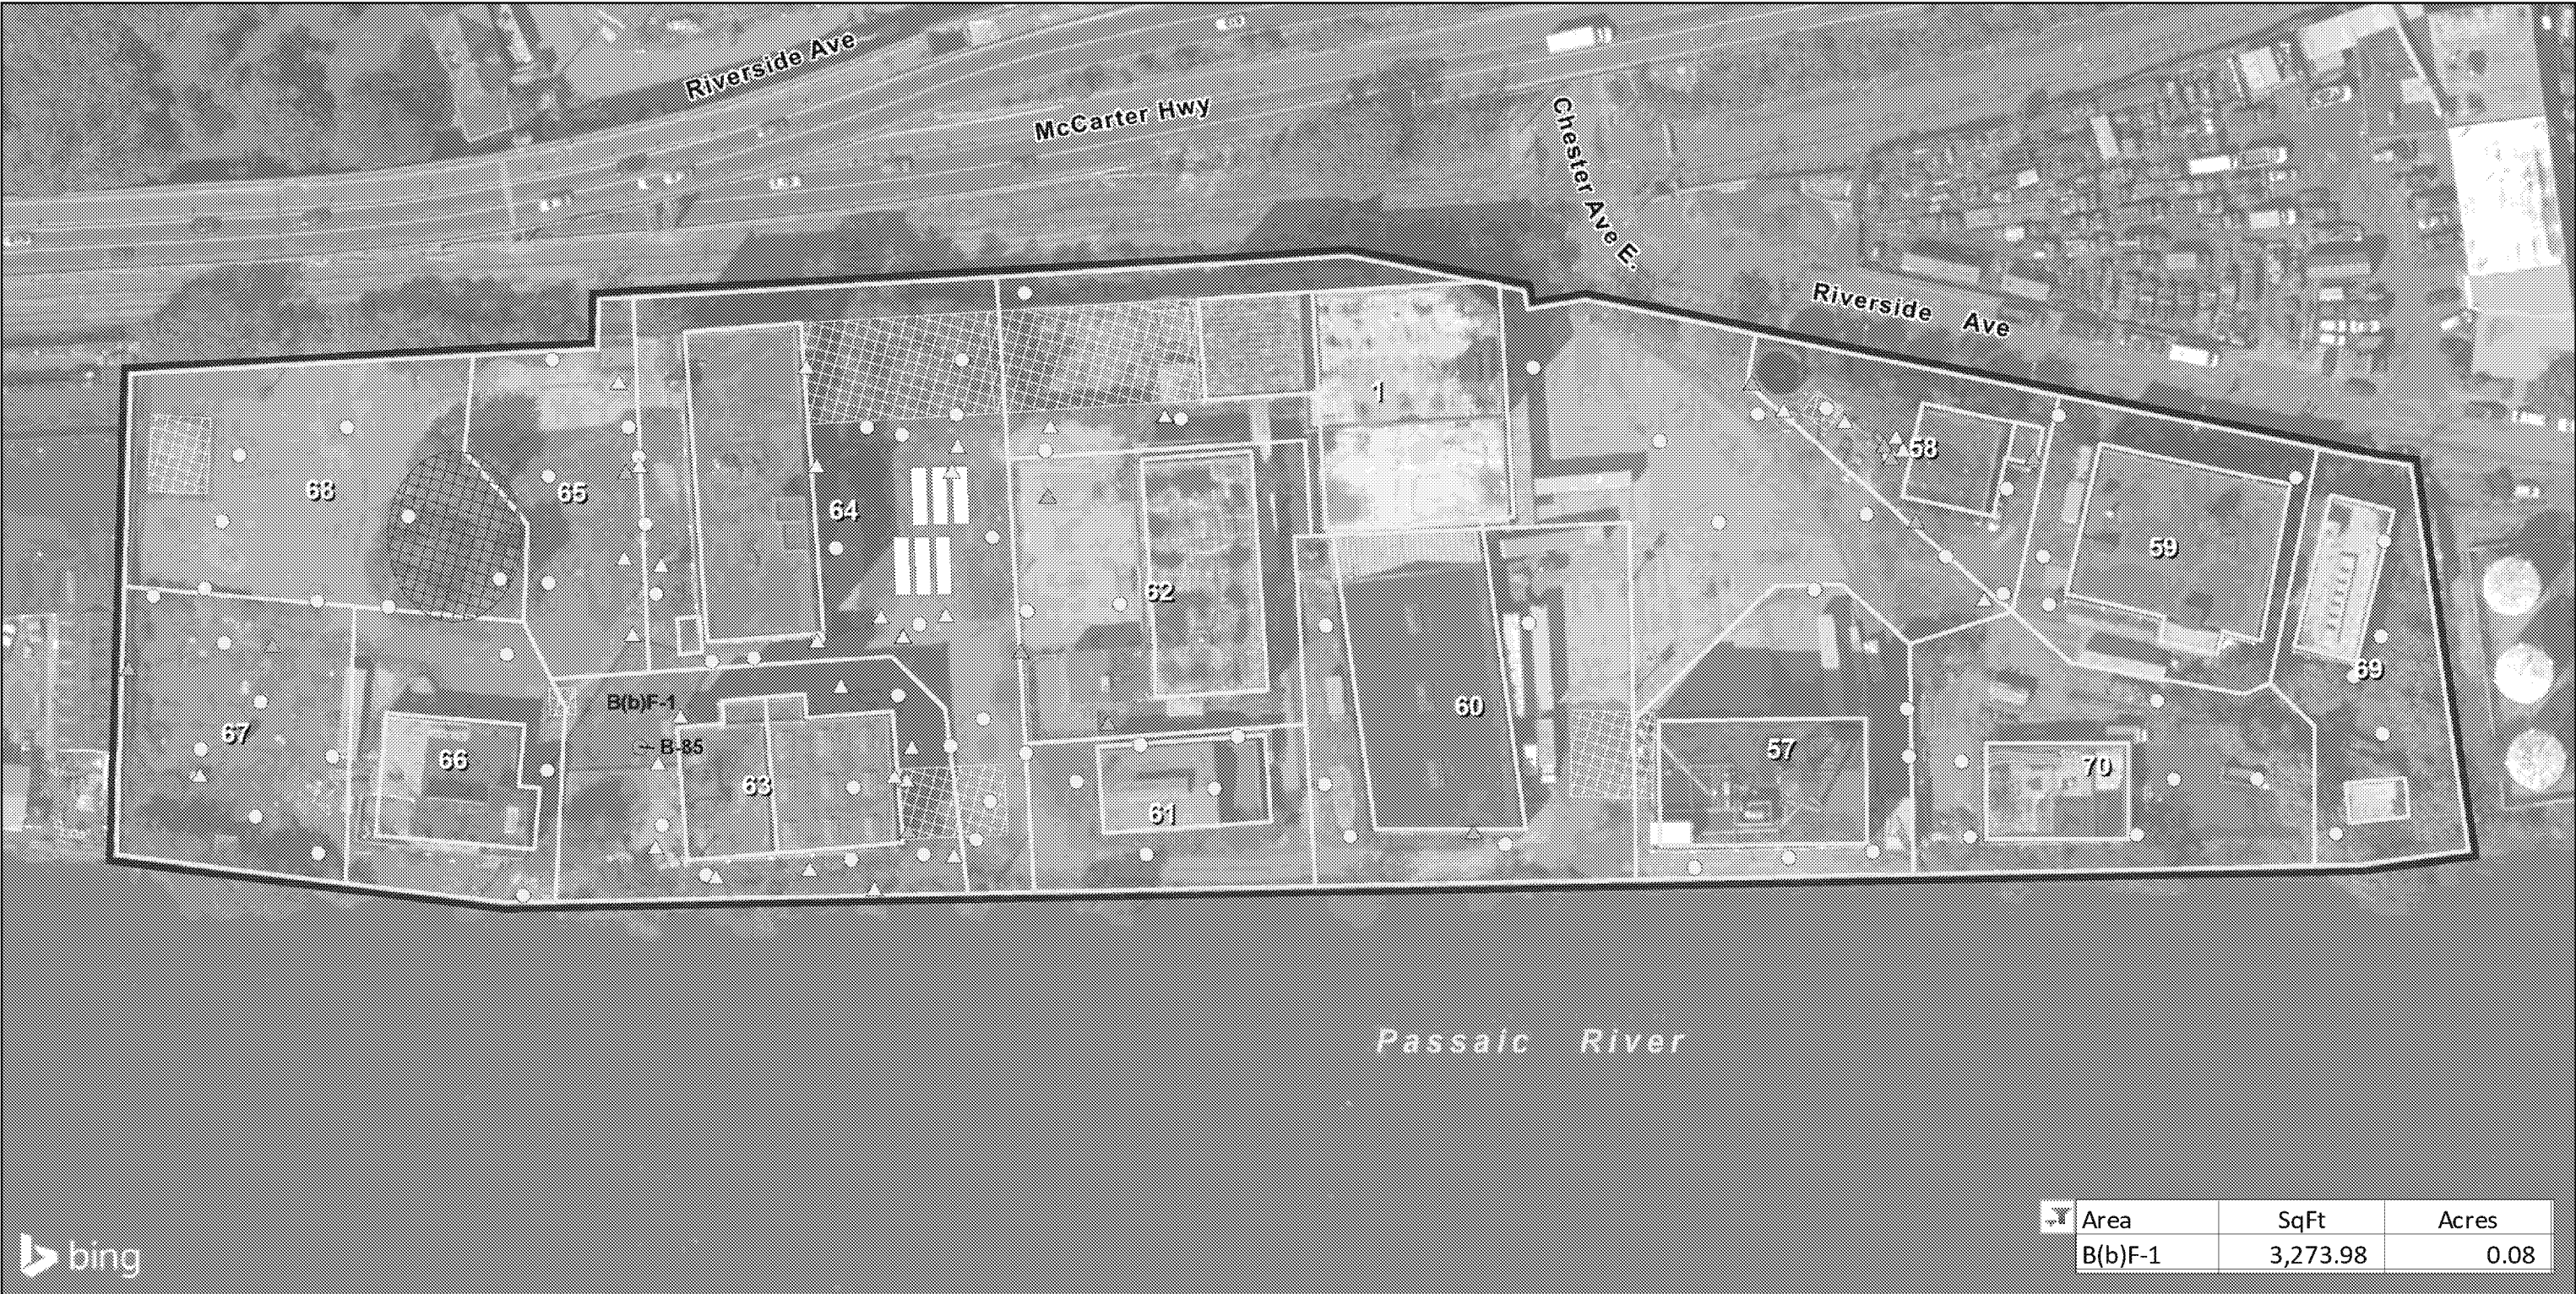
Figure A-6
Site-Wide Sampling Results for
Soil Alternatives: Benzo(b)fluoranthene
Riverside Industrial Park Superfund Site
Essex County, New Jersey

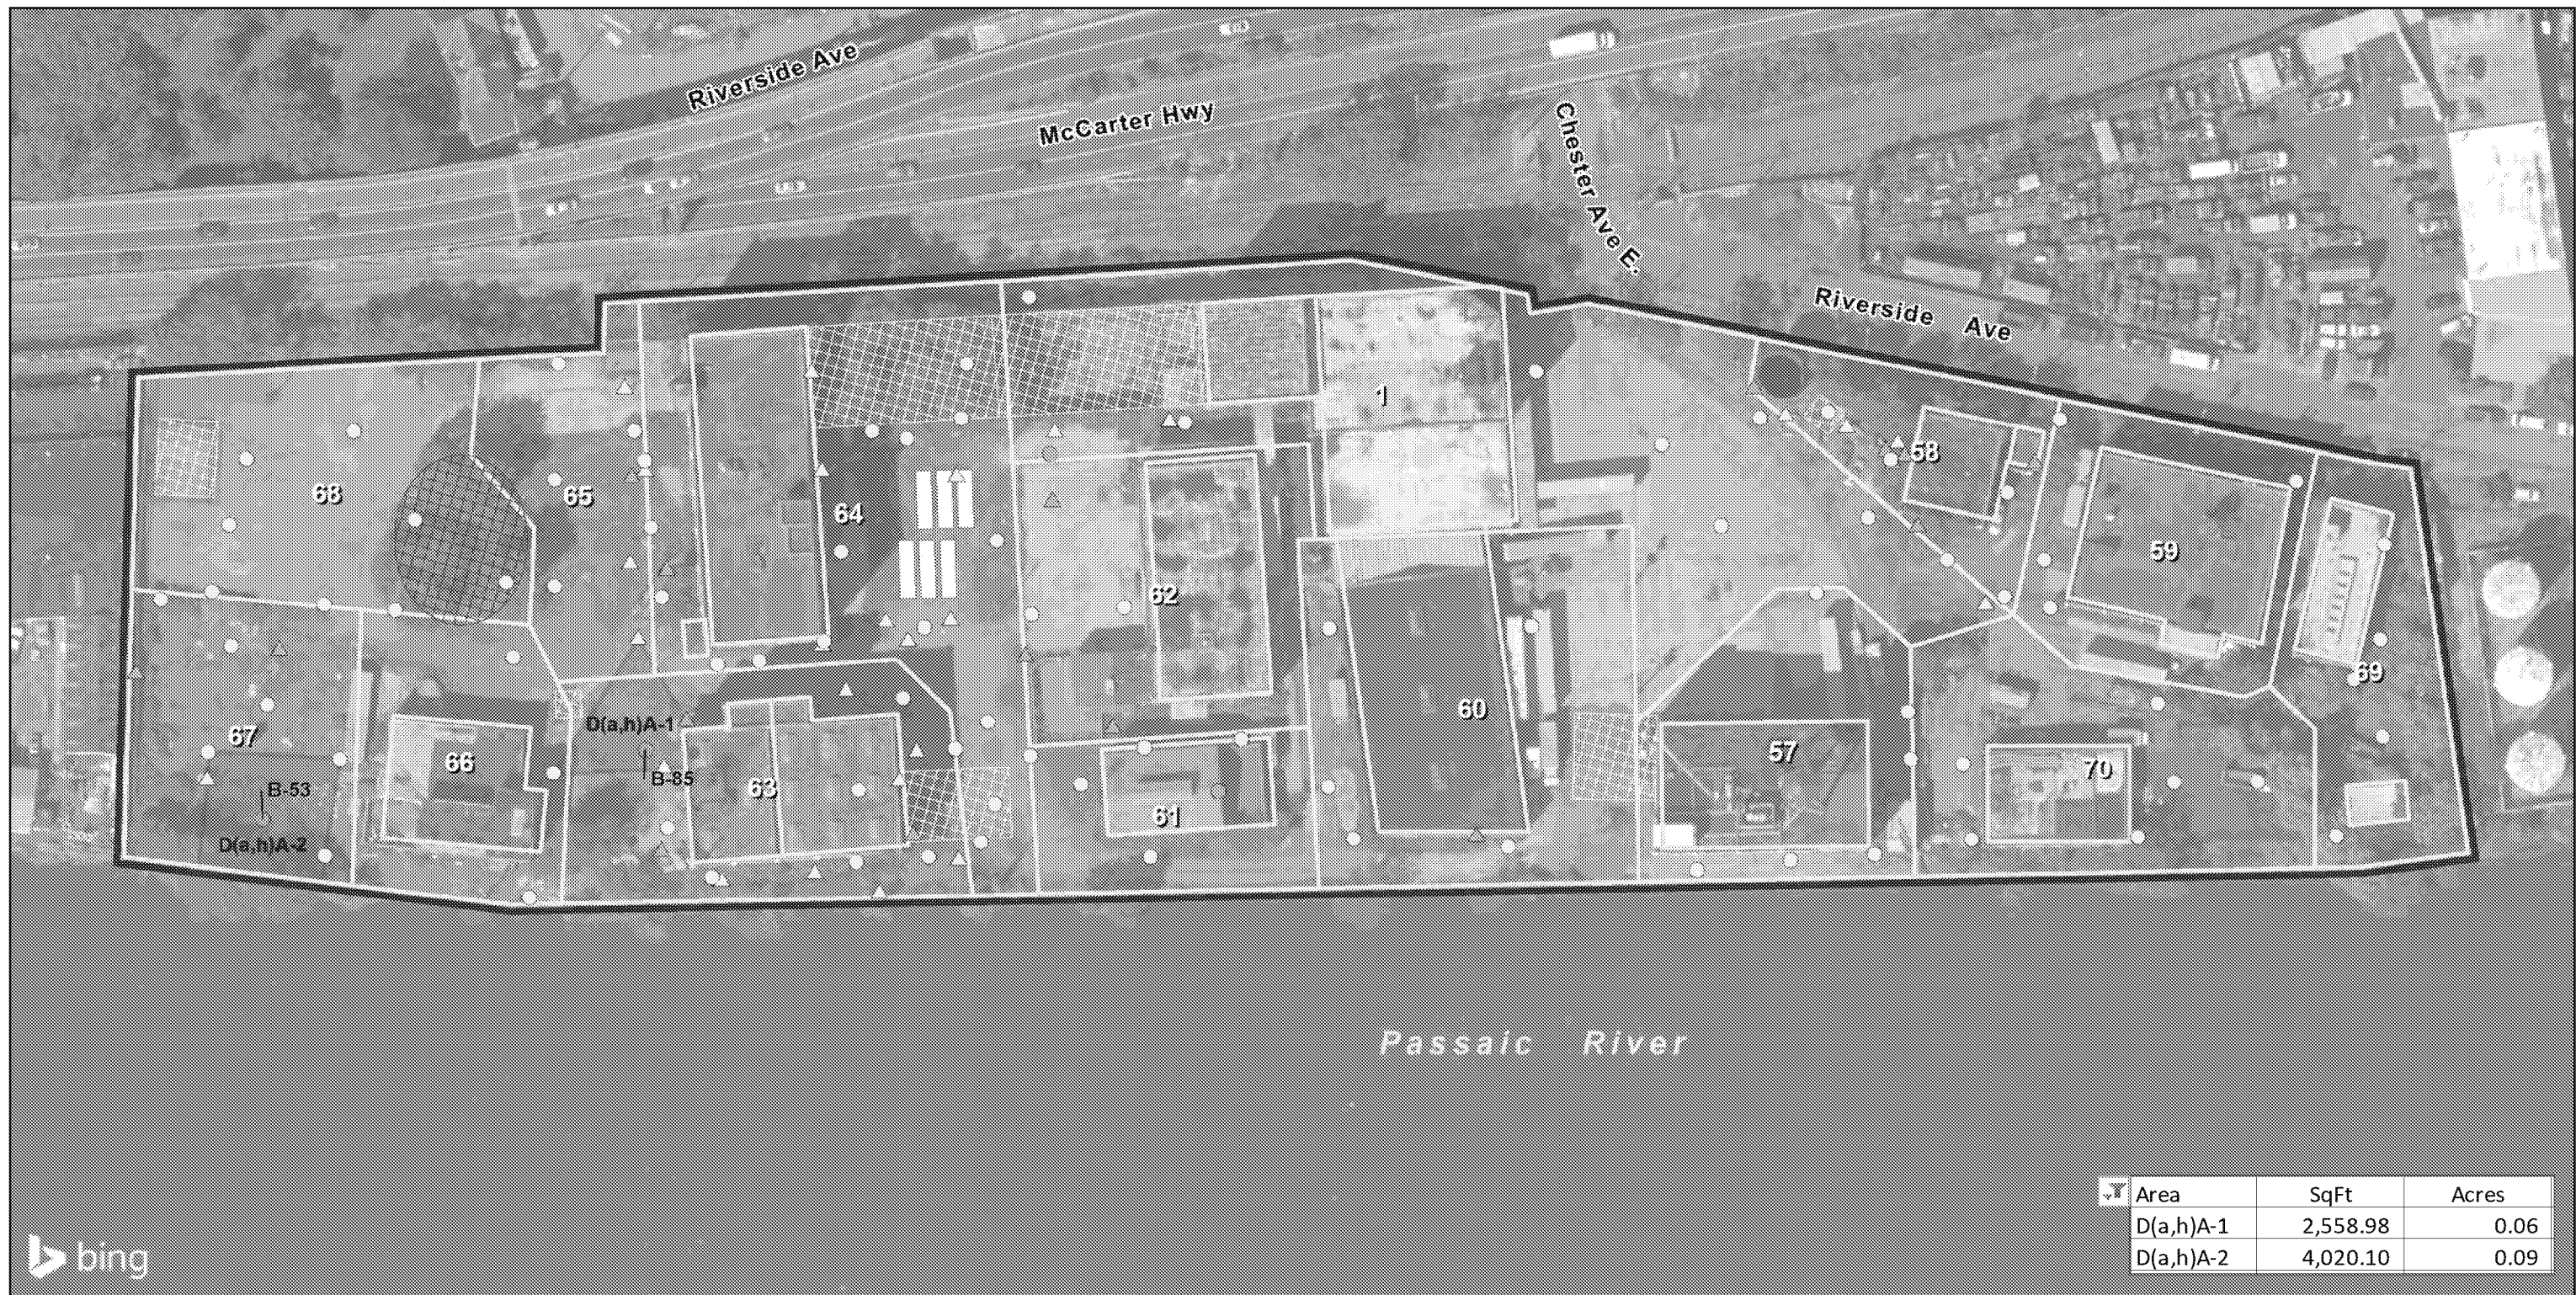
Figure A-7
Site-Wide Sample Results for
Soil Alternatives: Dibenzo(a,h)anthracene
Riverside Industrial Park Superfund Site
Essex County, New Jersey

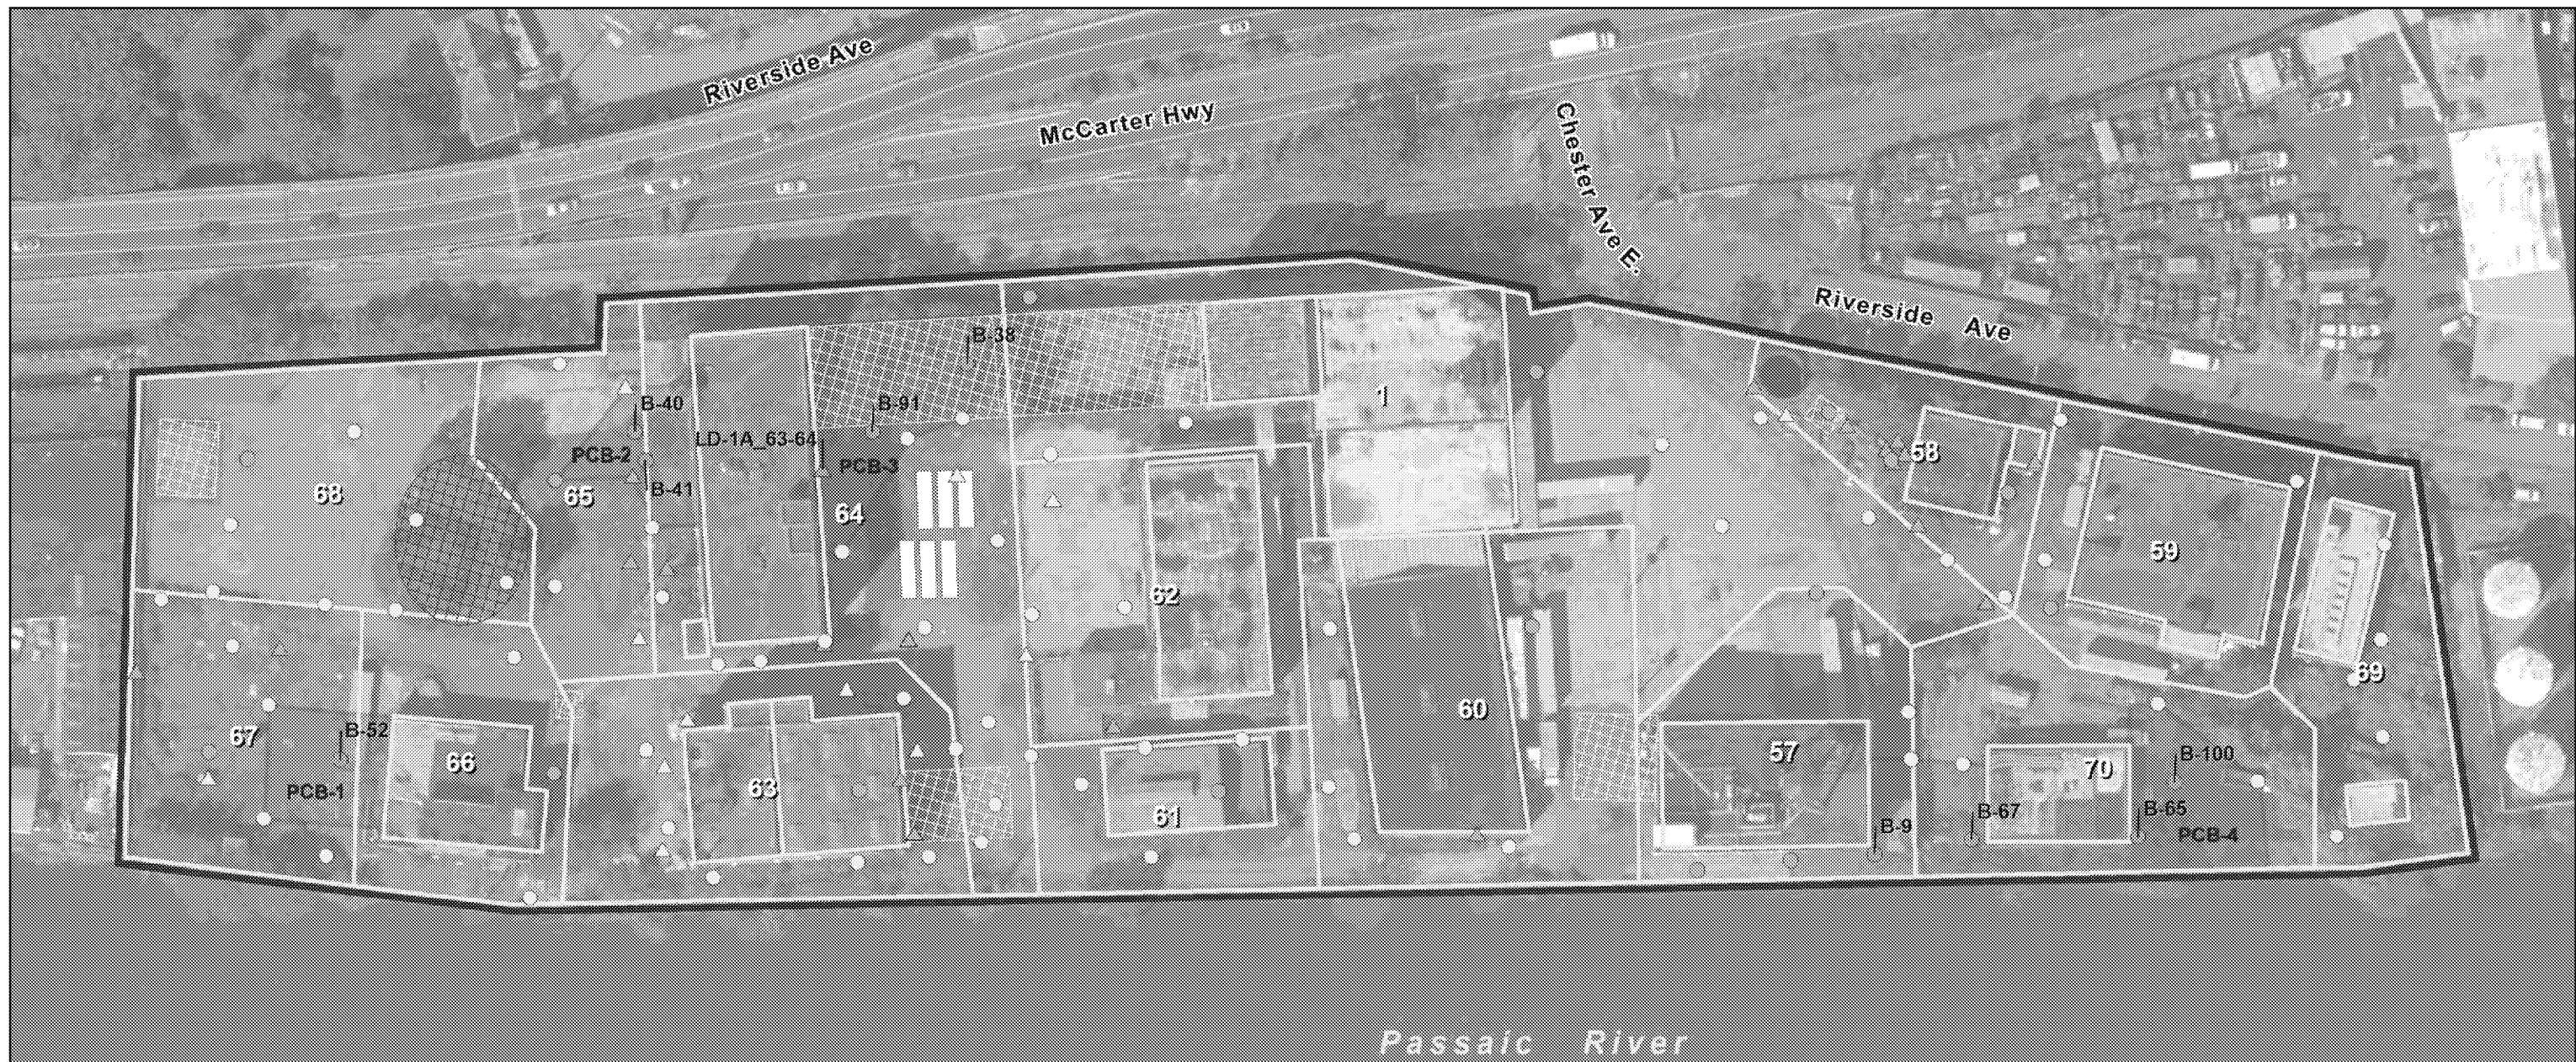
Area	SqFt	Acres
PCB-1	3,661.67	0.08
PCB-2	3,311.66	0.08
PCB-3	7,001.54	0.16
PCB-4	10,318.49	0.24

Figure A-8
Site-Wide Sampling Results for
Soil Alternatives: PCBs (Total)
Riverside Industrial Park Superfund Site
Essex County, New Jersey

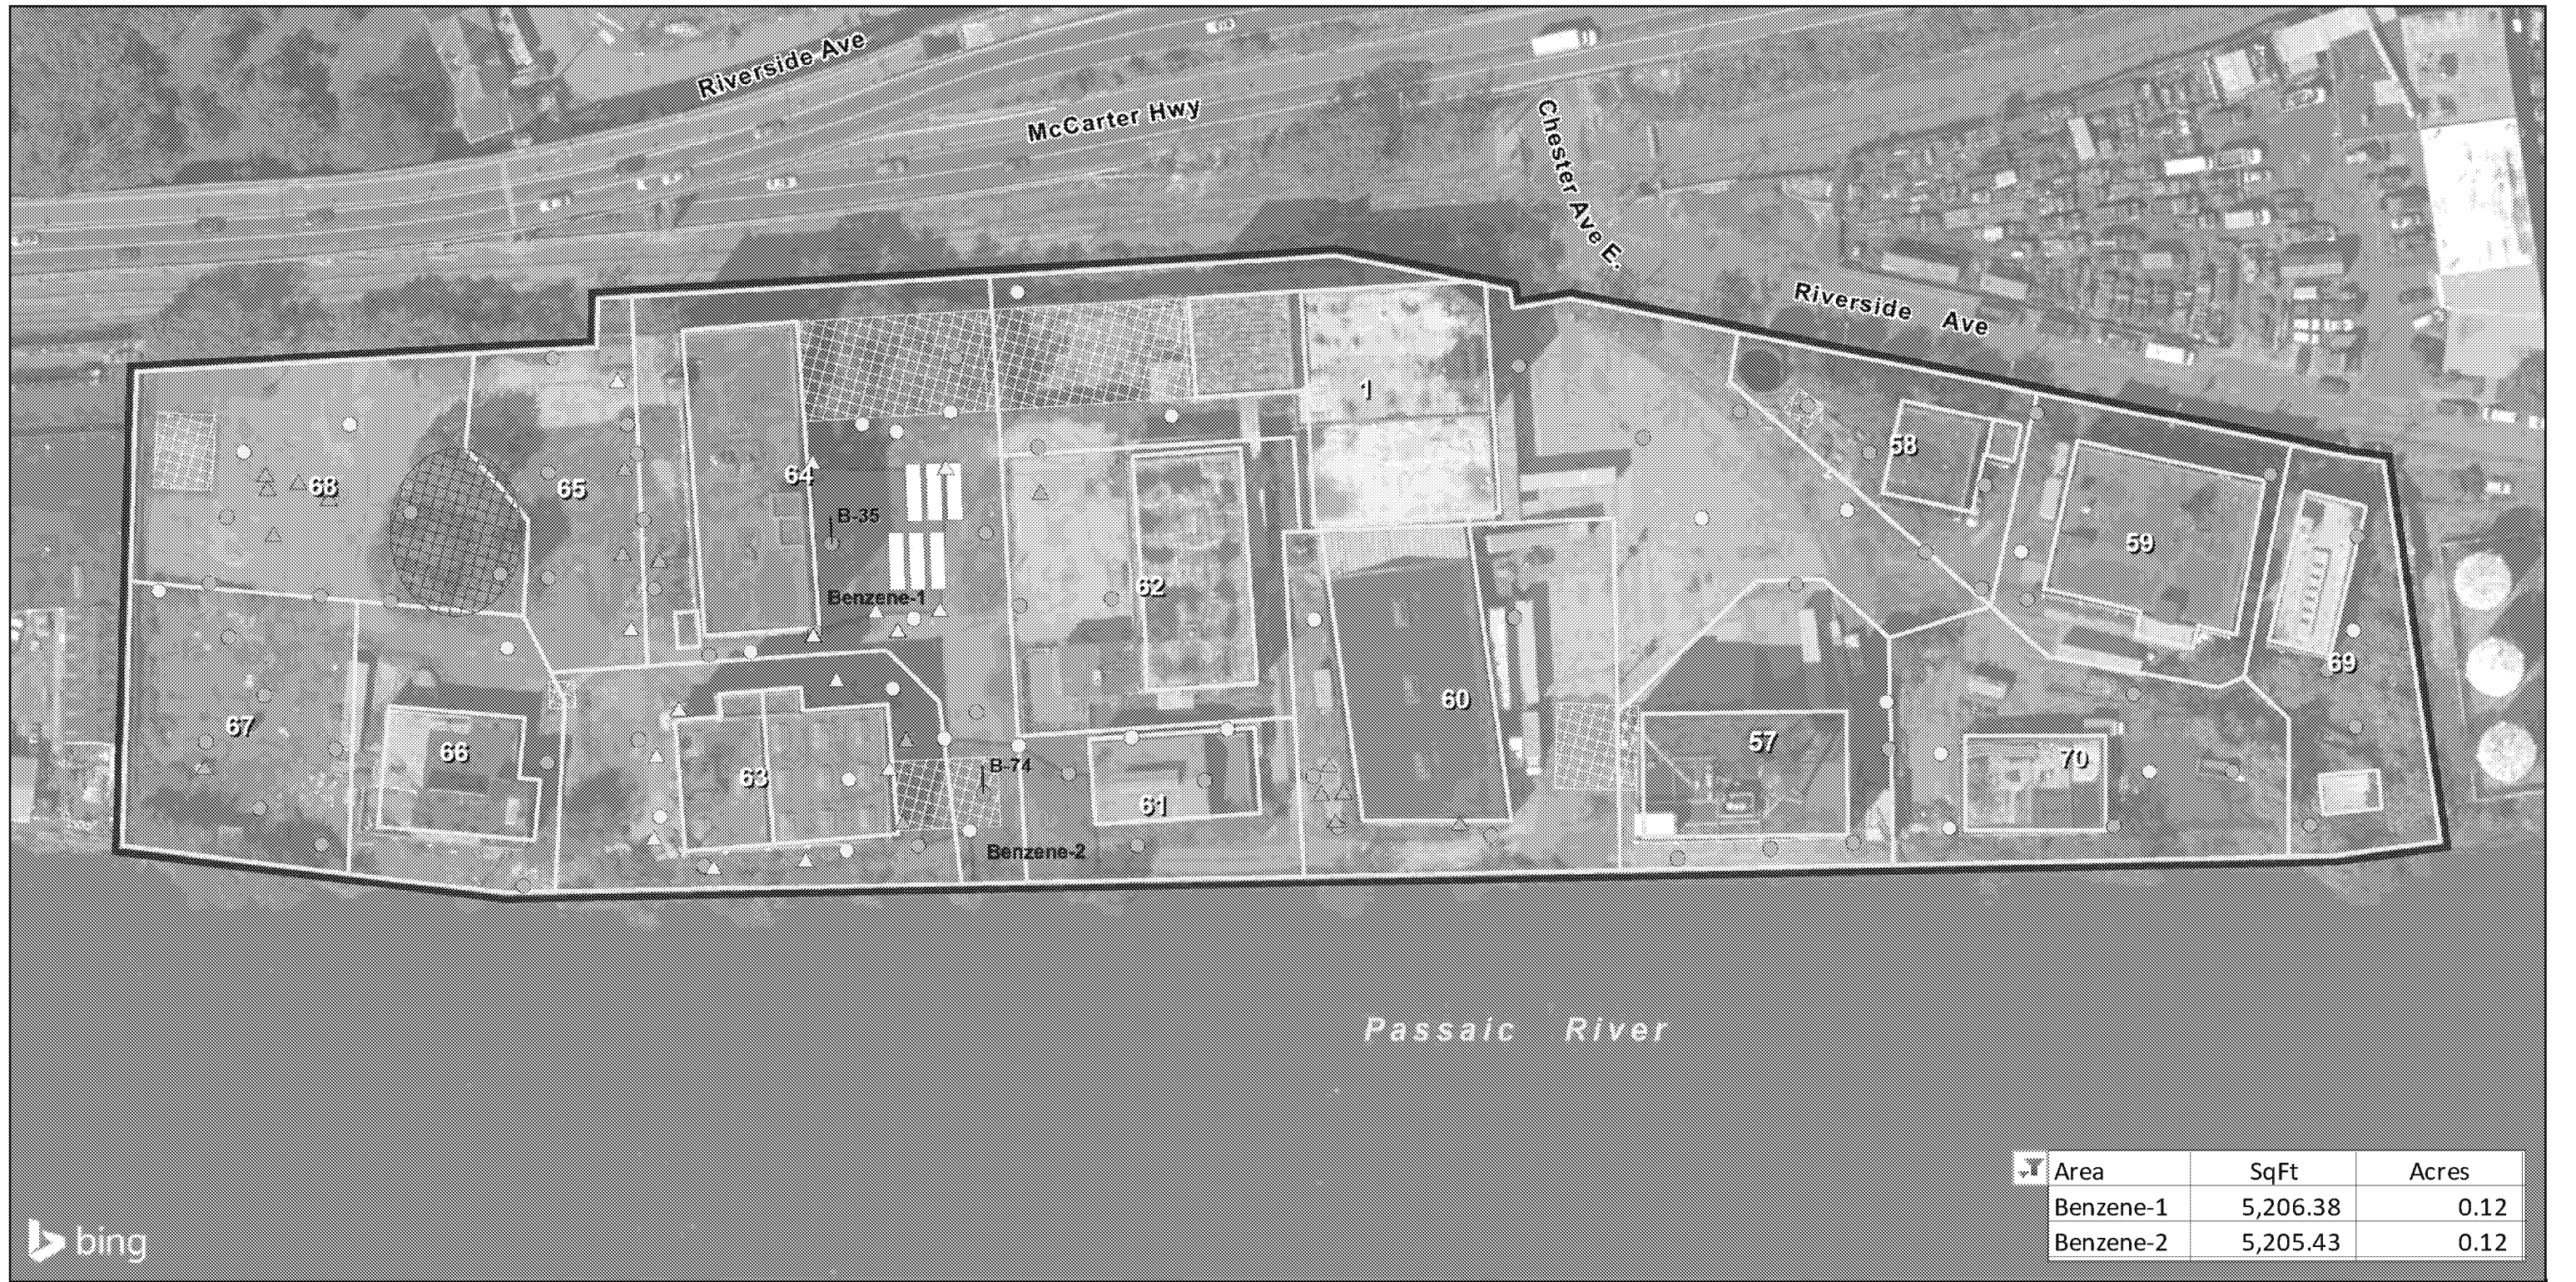
Figure A-9
Site-Wide Soil Sampling Results for
Soil Alternatives: Benzene
Riverside Industrial Park Superfund Site
Essex County, New Jersey
